MARYLAND HISTORICAL TRUST  
DETERMINATION OF ELIGIBILITY FORM

Property Name: Montjoy Farm Inventory Number: HO-145  
Address: 5000 ~~9097~~ Executive Park Drive City: Ellicott City Zip Code: 21042  
County: Howard USGS Topographic Map: Savage  
Owner: Estate of M.L. Dawson Lee, Jr. Is the property being evaluated a district? ☐ yes  
Tax Parcel Number: 260 Tax Map Number: 30 Tax Account ID Number: 243105  
Project: Montjoy Complex Agency: \_\_\_\_\_  
Site visit by MHT staff: ☒ no ☐ yes Name: \_\_\_\_\_ Date: \_\_\_\_\_  
Is the property located within a historic district? ☐ yes ☒ no

Prepared by: Ward Bucher Architects

Date Prepared: 6/30/2003

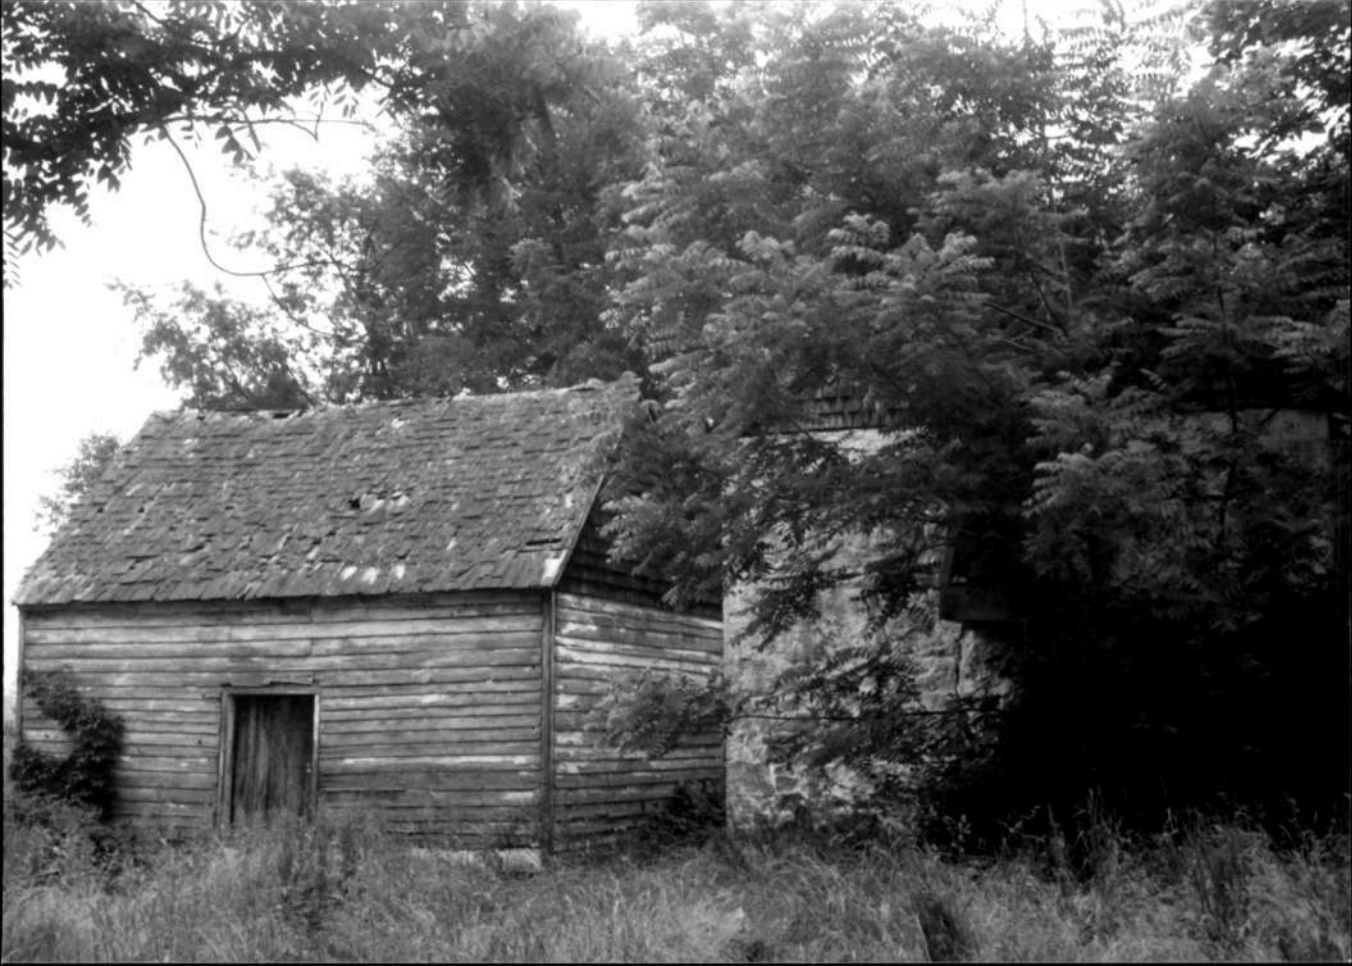
25/46

The building is in generally poor condition, with the roofing shingles in very poor condition with numerous holes, racked rafter pairs and rotten log top and bottom plates. Winchester Homes plans to maintain the exterior of the building along with the Montjoy house and the kitchen house ruin as part of the history of the site.

Smokehouse (left) + stone kitchen, west elevations

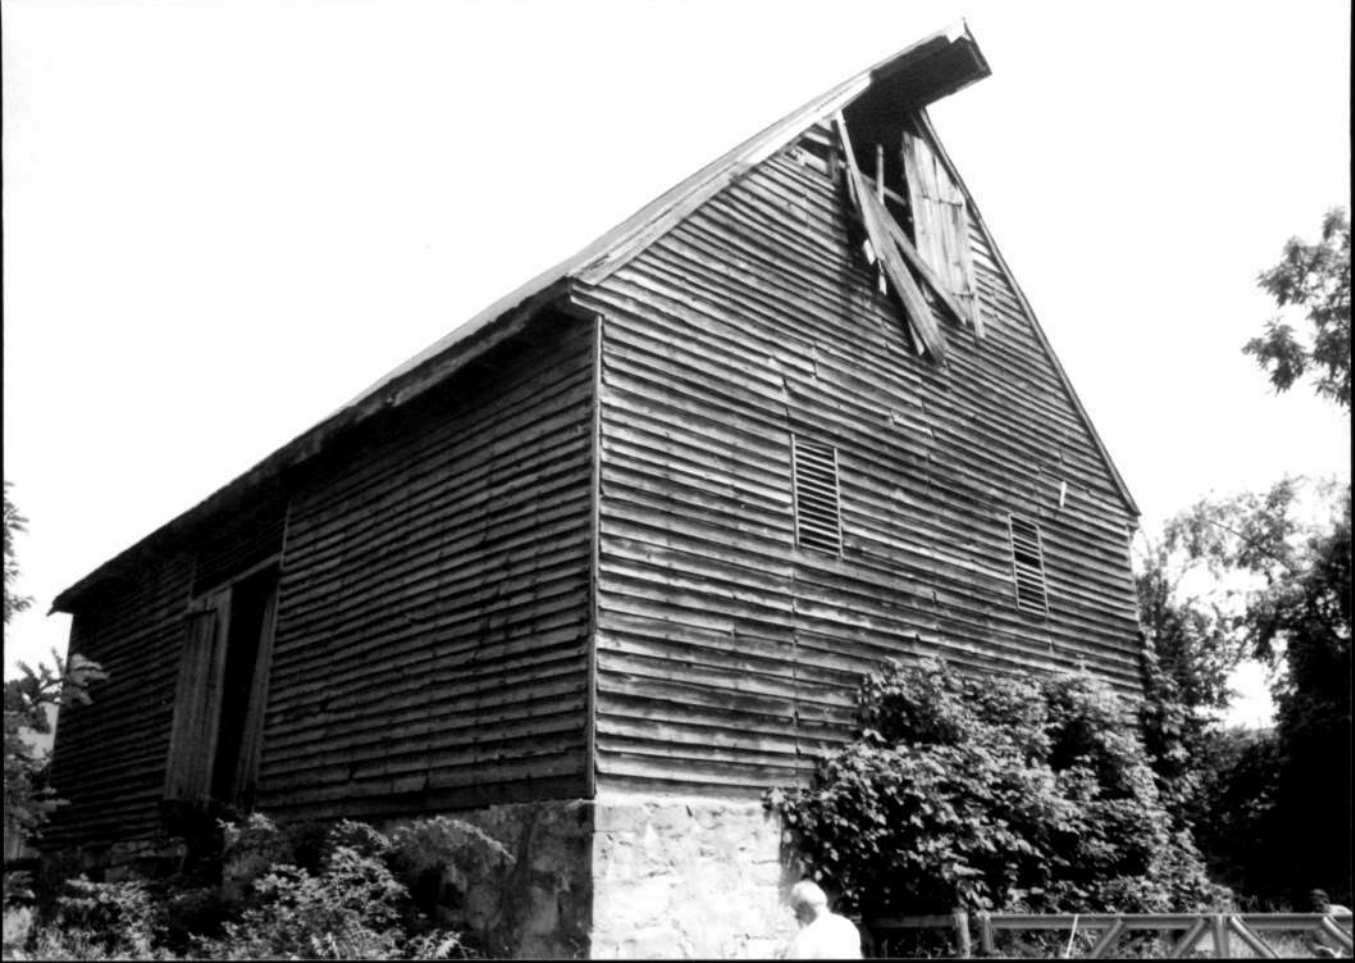
34/46

The general condition of the barn is good despite minor deterioration to the exterior, such as missing clapboard cladding at the peak of the west gable end. Winchester Homes proposes to give the barn to the Howard County Conservancy (HCC) for disassembly and reconstruction on the grounds of the HCC.

Three-bay barn, northwest elevation
